## Redcliff Battery

### History and Description

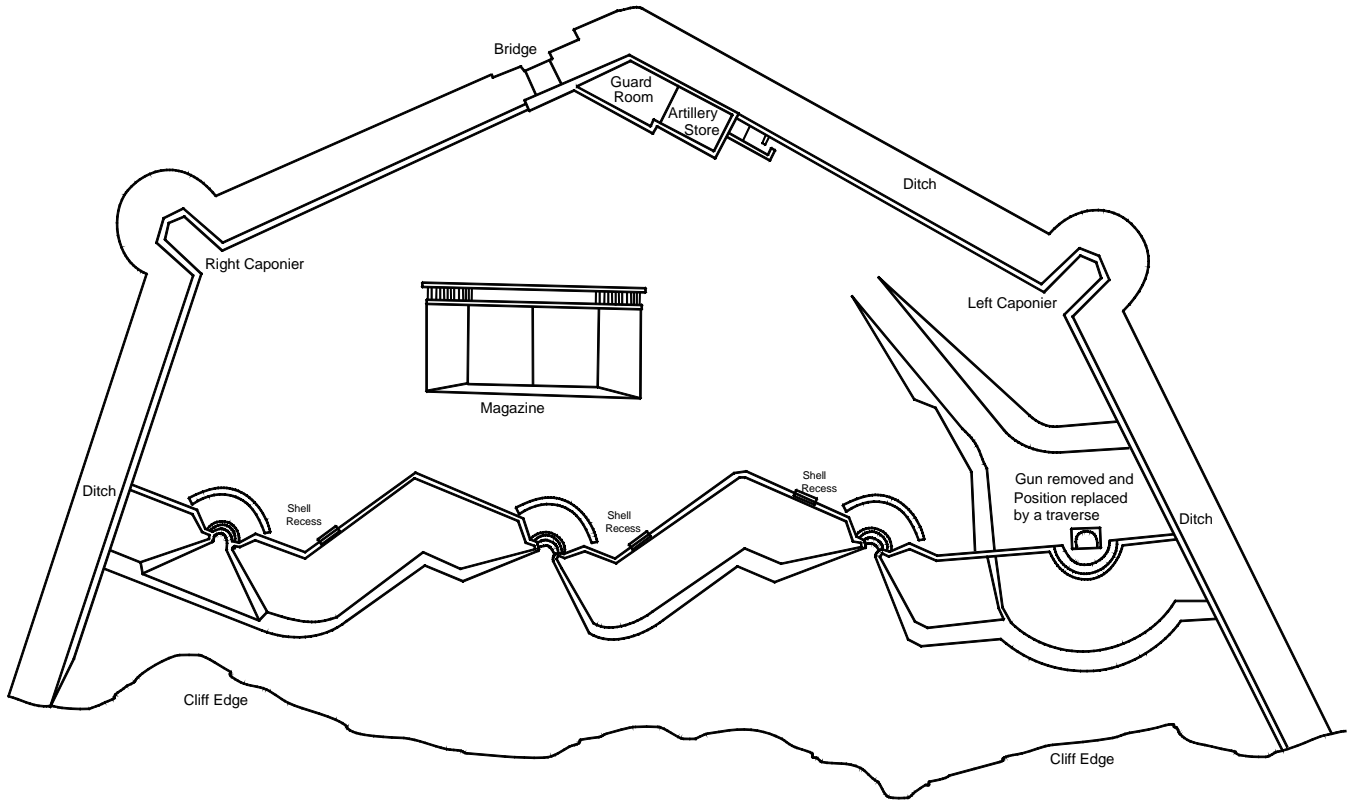
Redcliff Battery : Below: The site in 2008

In 2008 a few vestiges of the concrete gun positions were visible in the collapsing cliff.
